CENTRAL VALLEY REGIONAL WATER QUALITY CONTROL BOARD

INSPECTION REPORT

LOCATION & COUNTY: Henry Tosta Dairy
20662 San Jose Road, Tracy
San Joaquin County

INSPECTION DATE: 26 July 2012

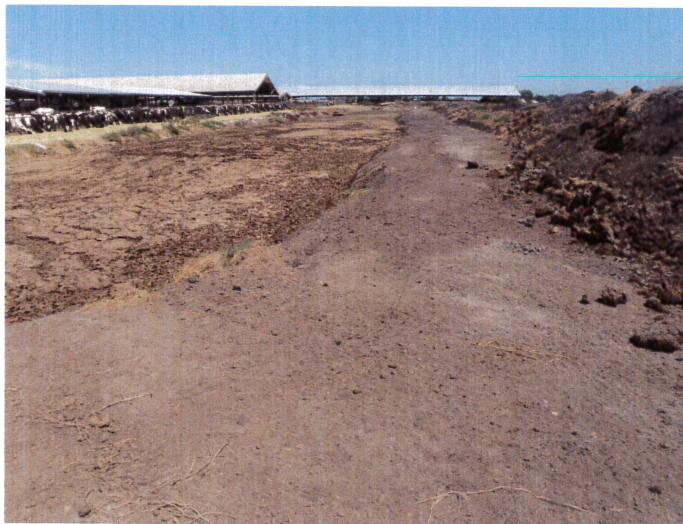
Settling Basin #1 – Significant solids have been removed and stacked on the adjacent embankment. Significant amounts of wastewater and solids are still present in the basin.

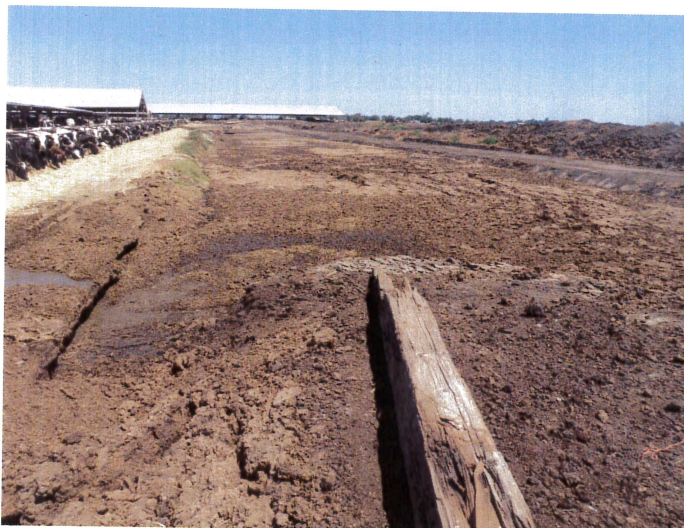
Settling Basin #1 – Significant solids have been removed and stacked on the adjacent embankment. Significant amounts of wastewater and solids are still present in the basin.

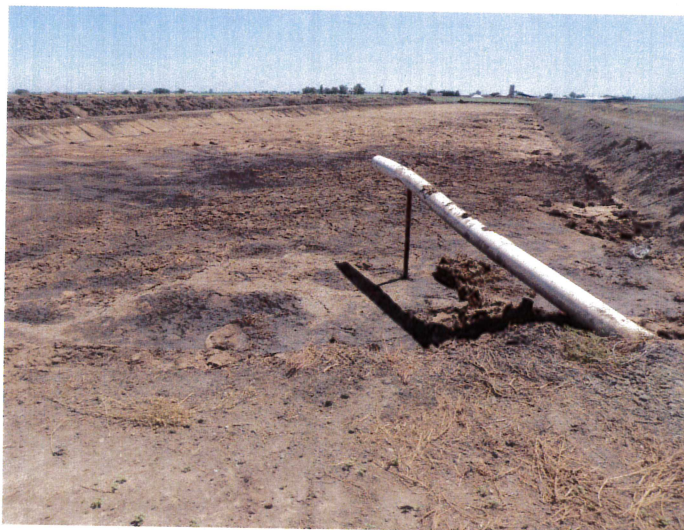
Settling Basin #2 – Significant solids have been removed and placed inside Wastewater Storage Lagoon #1. Significant amounts of wastewater and solids are still present in the basin.

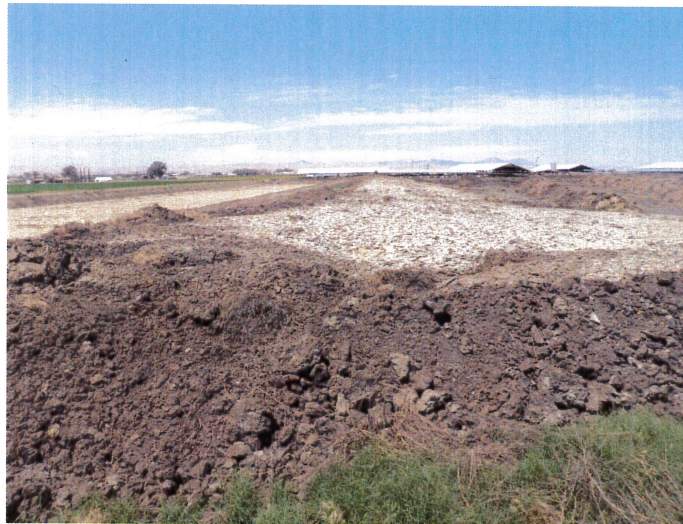
Settling Basin #2 seen in the left hand portion of photo. Wastewater Storage Lagoon #1 (Lagoon #1) is seen in the center of the photo. It appears the manure from Settling Basin #2 has been removed and put into Lagoon #1.

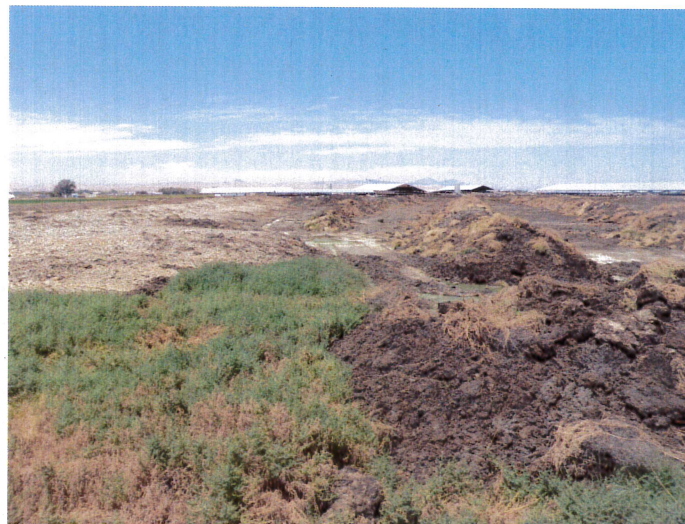
Lagoon #1 is seen in the extreme left hand portion of the photo. Wastewater Storage Lagoon #2 (Lagoon #2) is seen in the center of the photo. Manure removal operations have commenced at Lagoon #2. The manure inside Lagoon #2 is being windrowed. Staff could not determine if the lagoon embankments that divide Lagoon #1 and Lagoon #2 are still intact or have been destroyed during the clean-up process. Water was observed inside Wastewater Storage Lagoon #2.

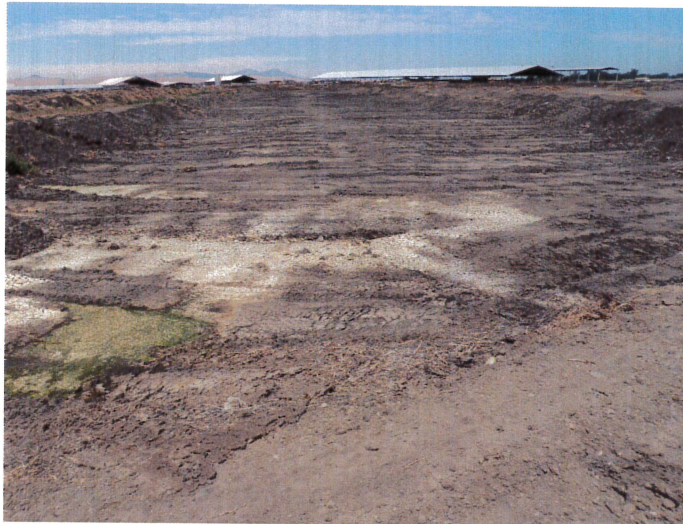
Wastewater Lagoon #3 has been cleaned down to native soil. A small amount of dry solid manure still remains in the lagoon.

Staff is concerned that during the clean-up process the lagoon embankments have been destroyed or damaged.

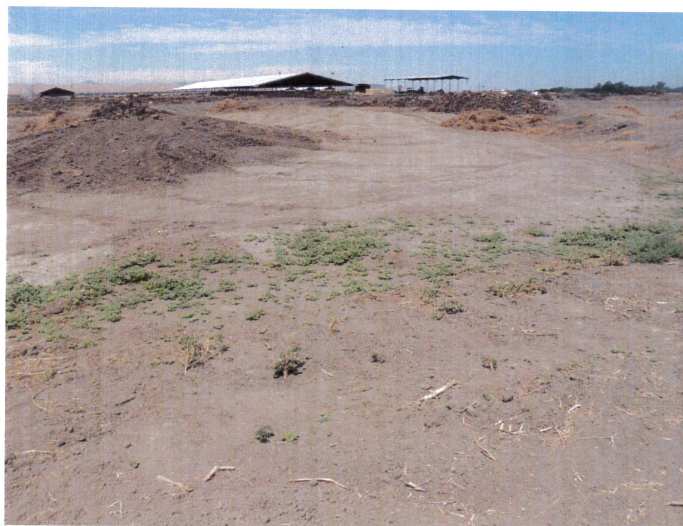
Wastewater Lagoon #4 has been cleaned down to native soil. A small amount of dry solid manure still remains in the lagoon.

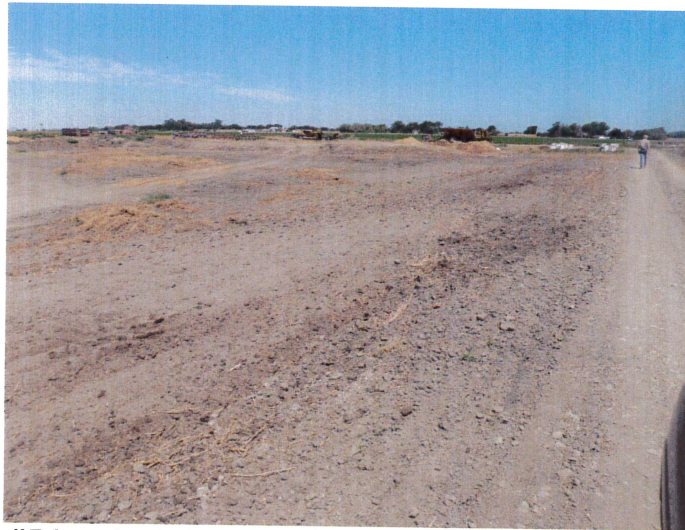
Wastewater Lagoon #5 has been cleaned down to native soil. A small amount of dry solid manure still remains in the lagoon.

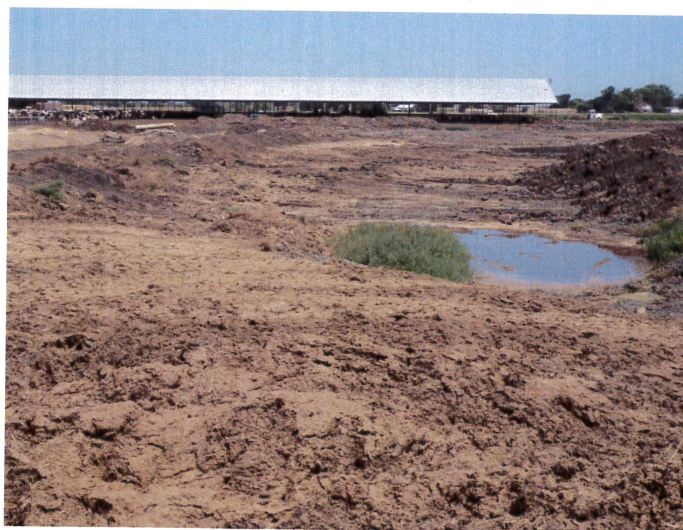
It didn't appear to staff that manure removal has commenced from the 3-4 acre area of native soil. See photos below:

Looking north at the 3-4 acre area of native soil.

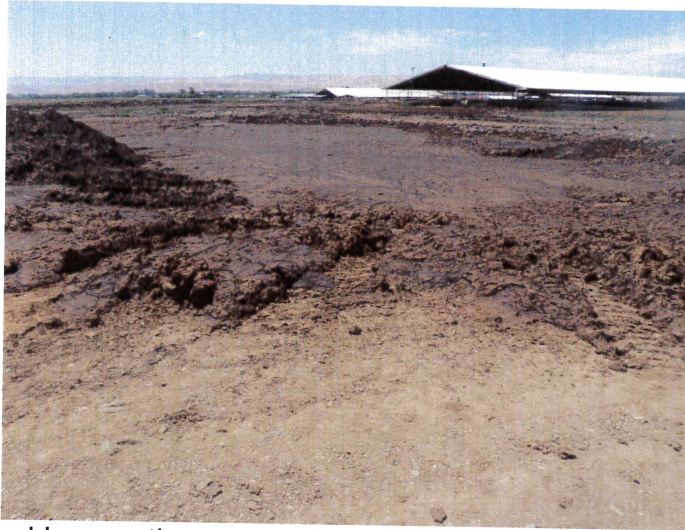
Looking southwest at the 3-4 acre area of native soil

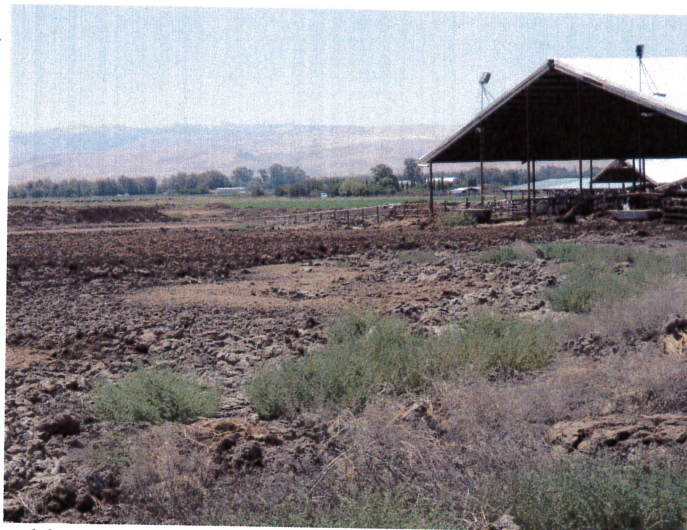
Looking southwest at the 3-4 acre area of native soil

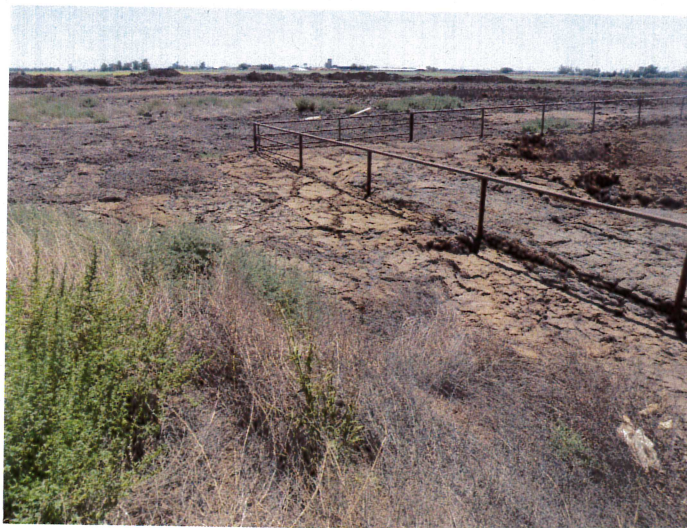
Looking southeast at the 3-4 acre area of native soil

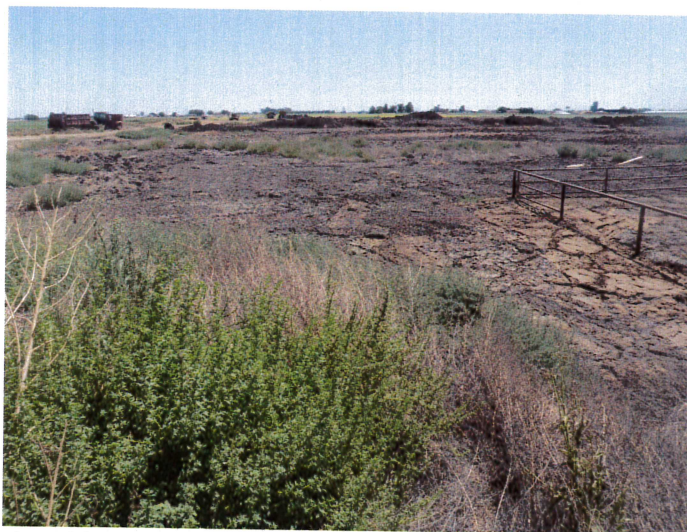
Looking east at the 3-4 acre area of native soil.
